Mount 7 Rec Plex

Facility Assessment

December, 2010

Town of Golden

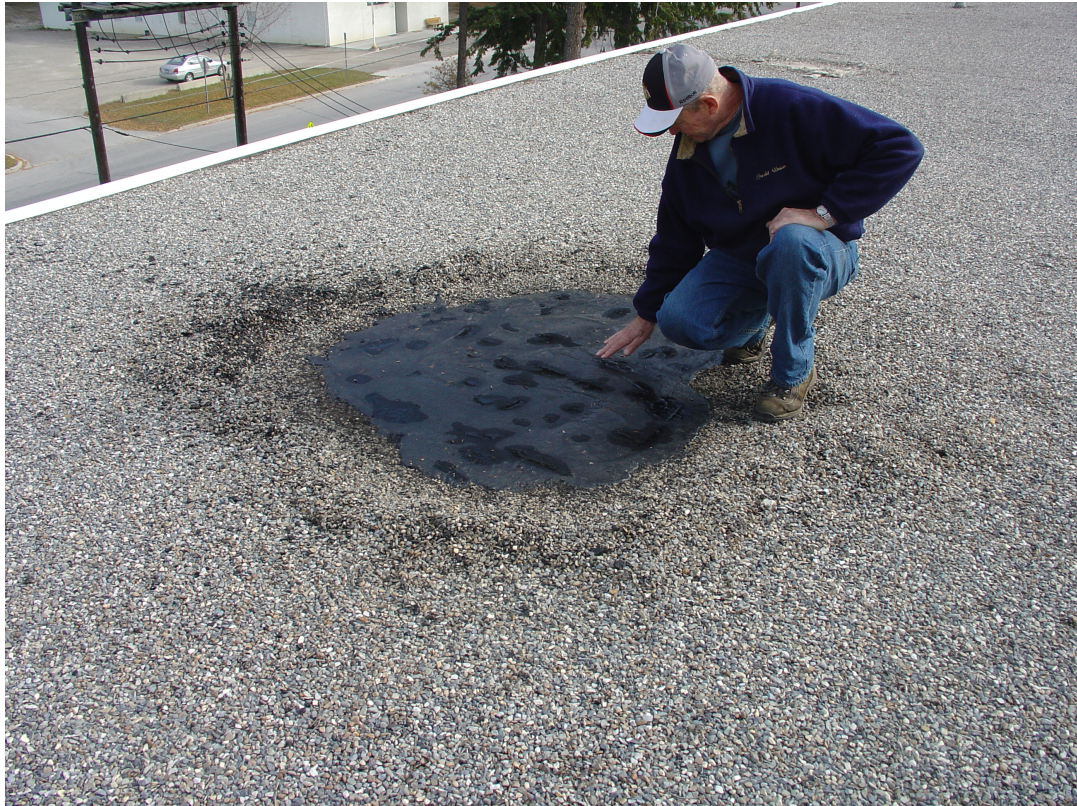
The roof assembly was visually reviewed. The roof is at the end of its intended life cycle as evidenced by a growing number of leaks being reported and repaired. During the visual review it was noted that the built-up roof is blistering in several areas and will continue to do so making the need for piecemeal repairs an ongoing problem. The recommended course of action regarding the roof assembly is to at minimum, replace the main roof over the gymnasium.

roof membrane blisters on the gymnasium roof

- Replacement of Roof membrane. (\$54,000)
- Fire Rating of Rotary Storage Room. (\$5,000)
- Ventilation Duct Cleaning. (\$5,000)
- Repair of water damaged exterior stucco and interior finishes. (\$25,000)
- Removal and replacement of exterior concrete pads. (\$10,000)
- Replacement of male shower wall protection. (\$4,000)
- Replacement of Basketball backstop winches. (\$2,000)
- Replacement of exterior Mechanical Room doors. (\$2,000)

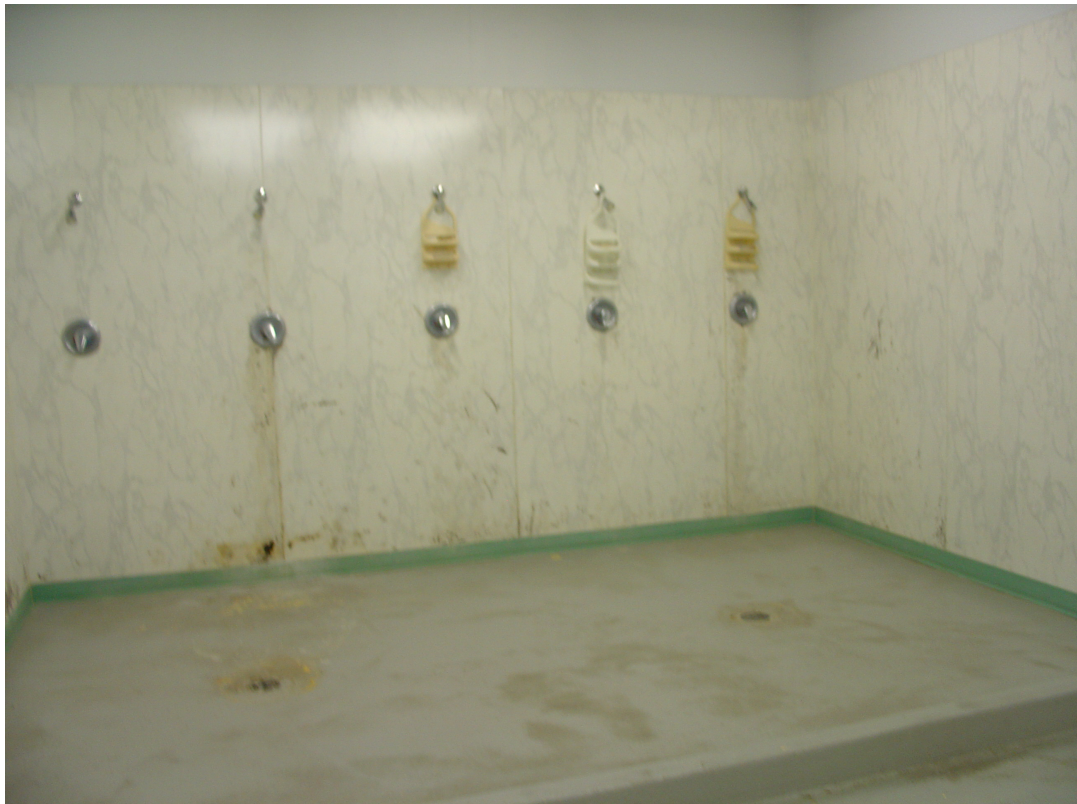
deteriorated wall finish in male showers

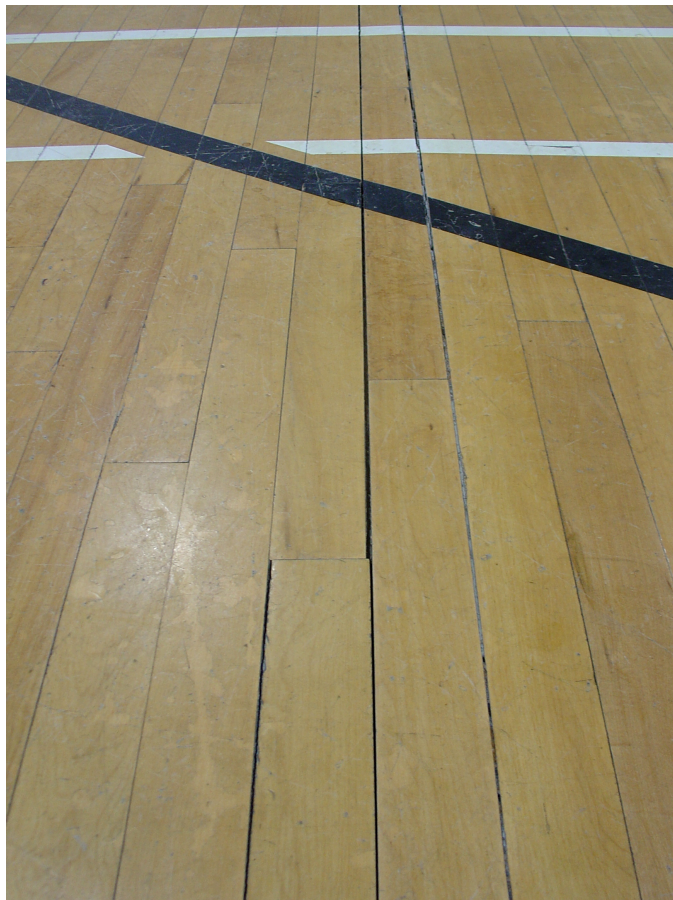
- The existing gymnasium floor underwent a repair/refinishing approximately 10 years ago due to water damage from a frozen water pipe. The refinishing project was not properly conducted and as a result the floor quickly showed finish de-lamination. Over time in several areas, floor board joints have opened allowing cleaning solutions to drain below the floor surface likely causing some rot and warping which in turn has contributed to further deterioration. Warping is evident in several areas where the flooring section has lifted above the concrete bed. Additionally the state of repair of the roof assembly over the gymnasium contributed to several recent leaks and ponding on the floor surface.

gymnasium floor gaps

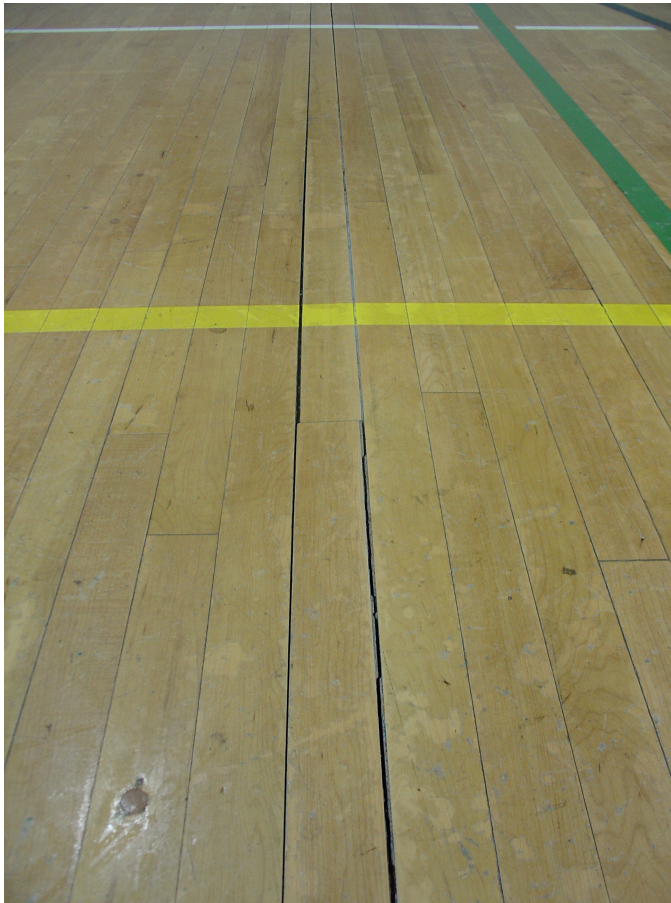
gymnasium floor gaps

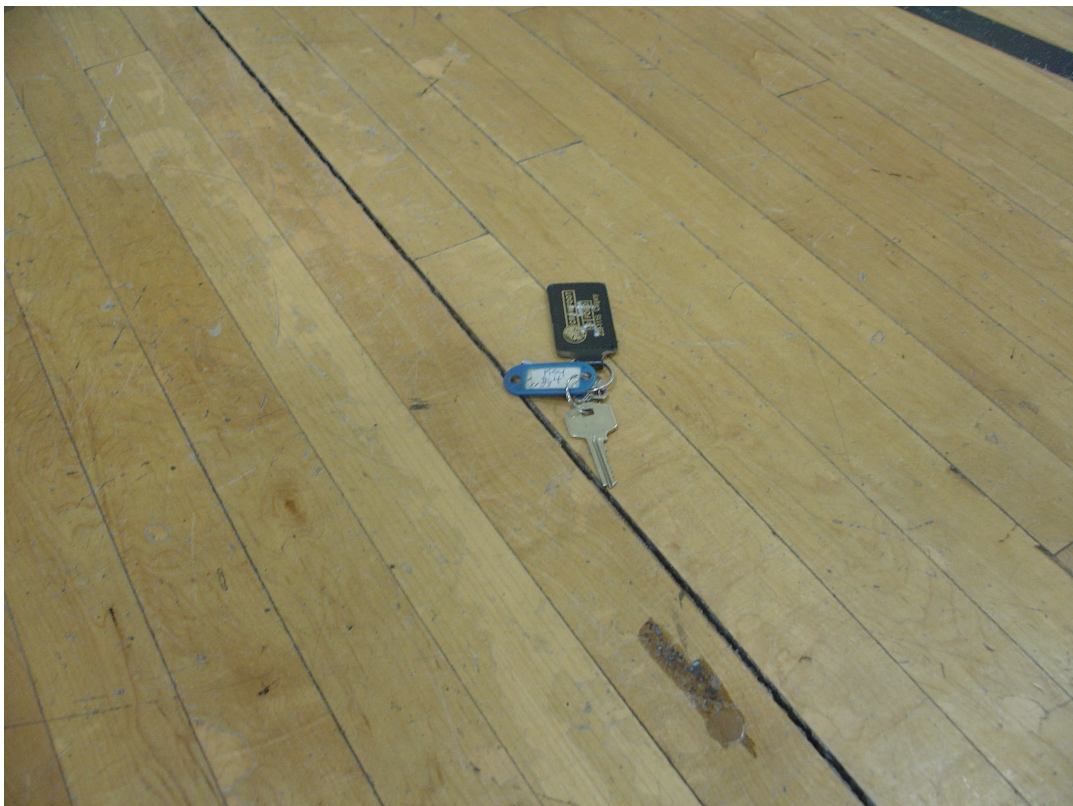
gymnasium floor gaps

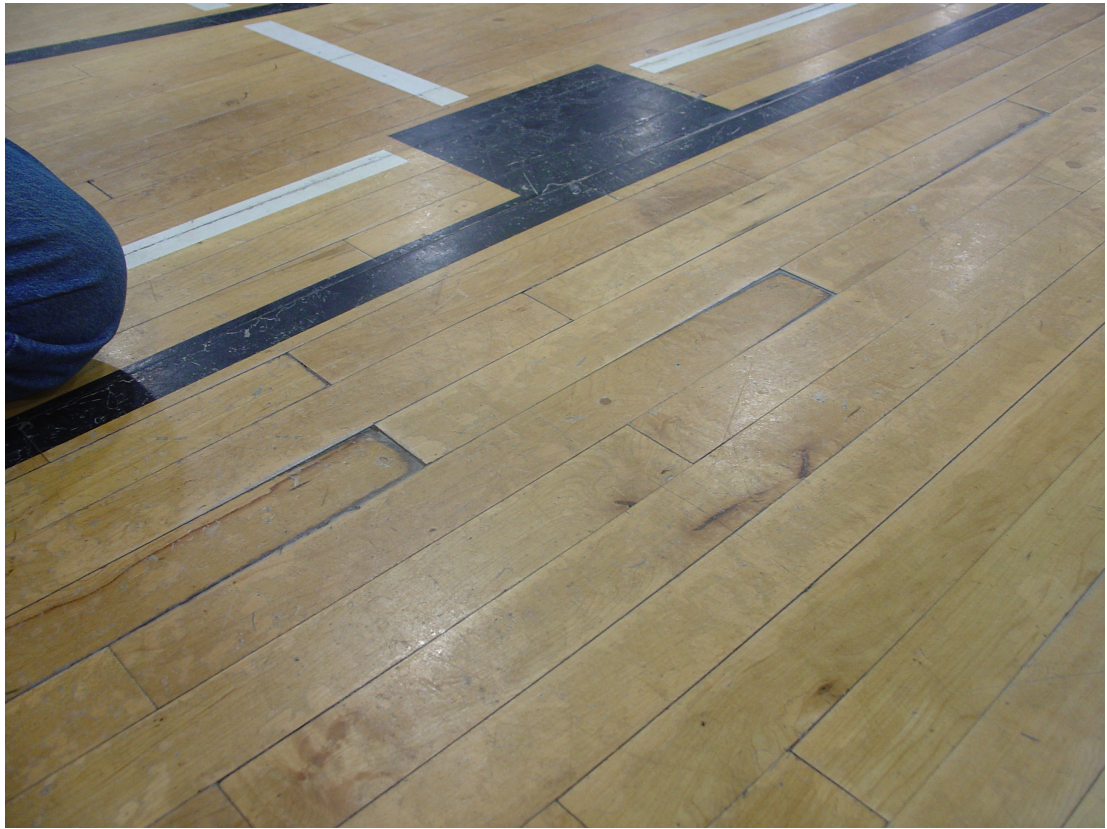
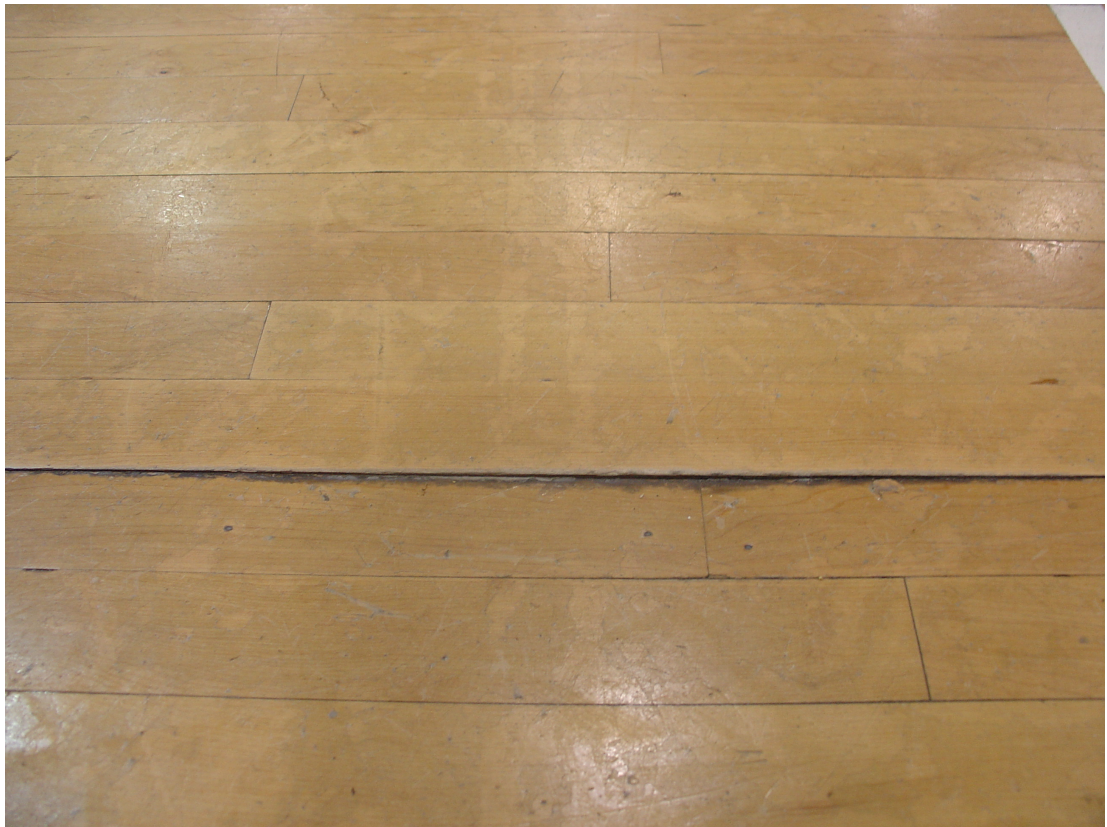
gymnasium floor plank deterioration causing ponding

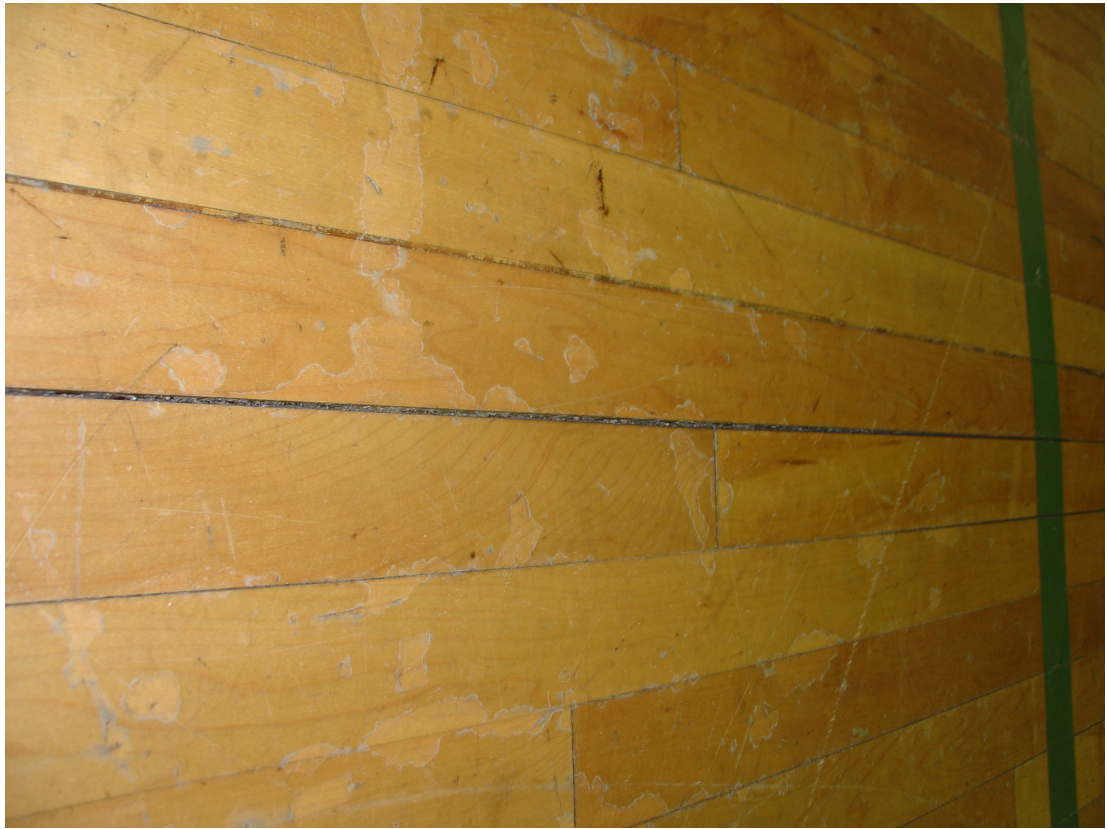
gymnasium floor finish de-lamination

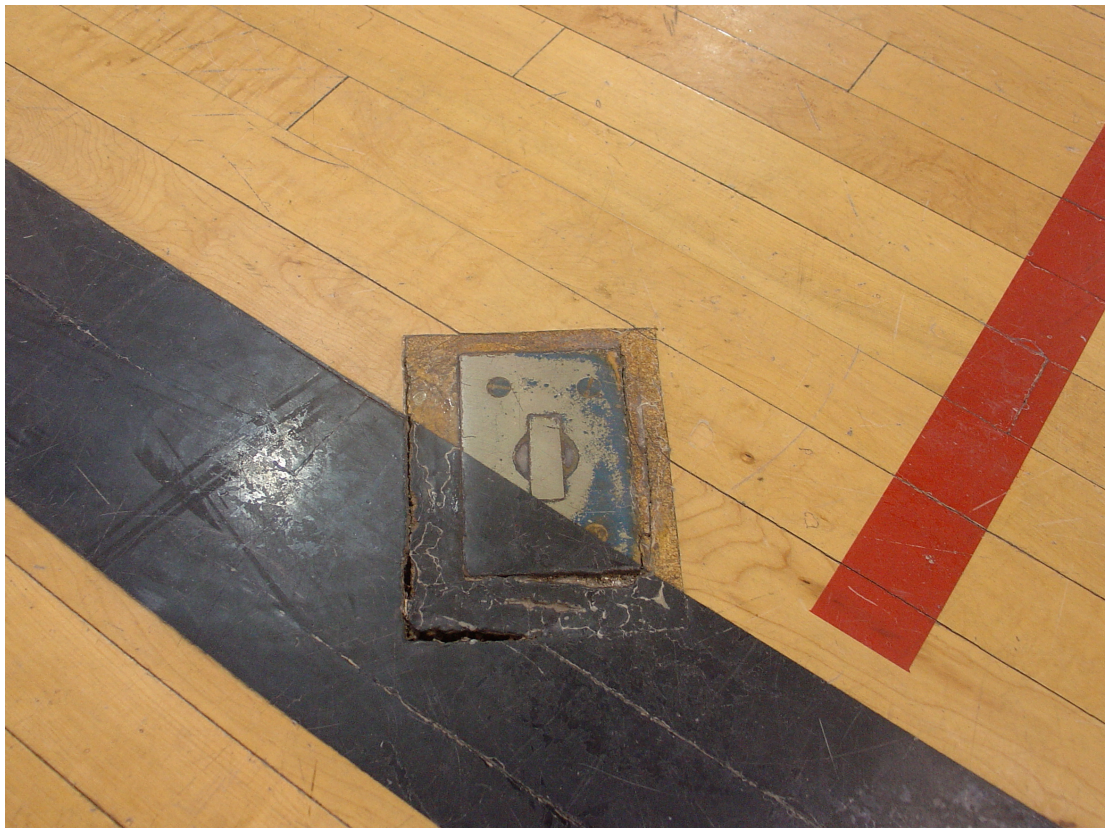
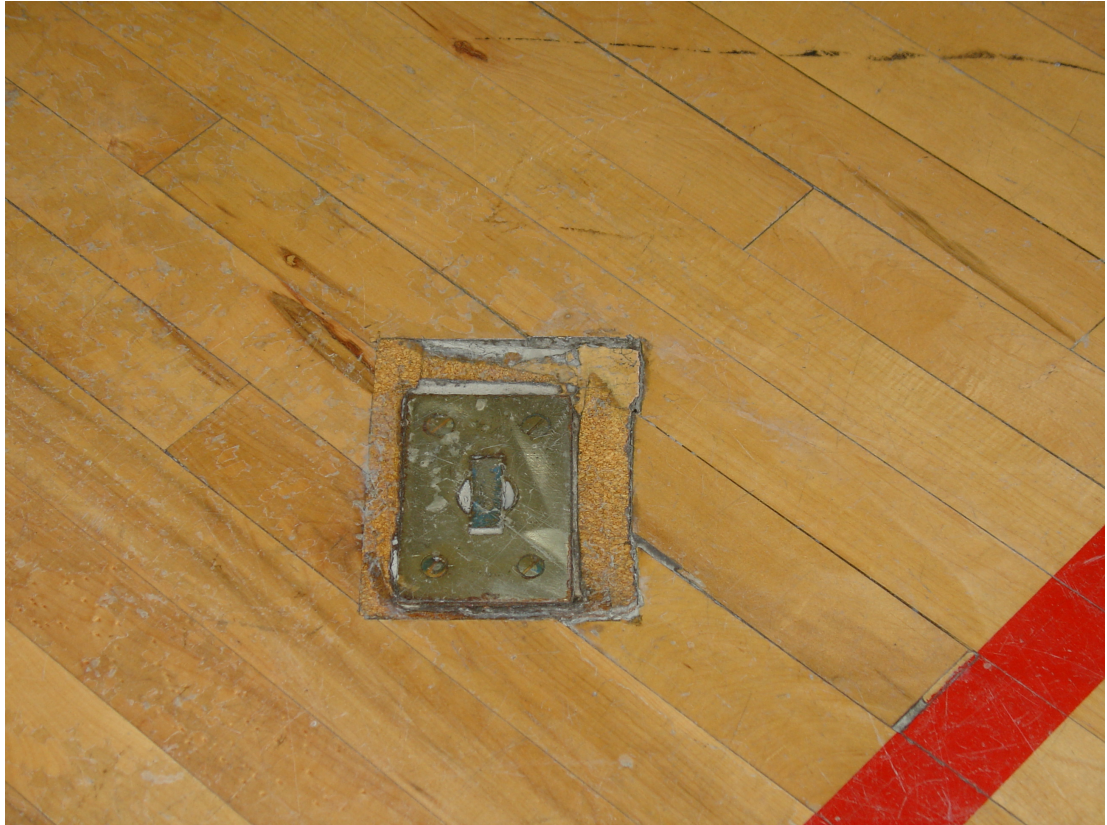
poorly installed gym floor insert

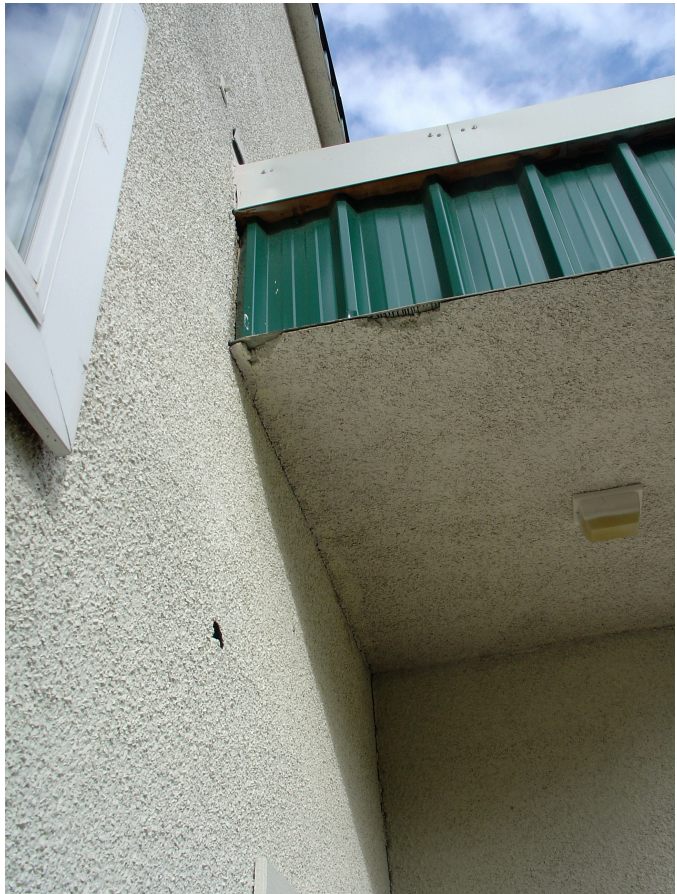
The exterior envelope is clad with a combination of pre-finished metal siding and a stucco finish. Based upon a visual review, the exterior stucco finish in places requires repair to prevent further deterioration of the exterior wall system.

deteriorated stucco wall

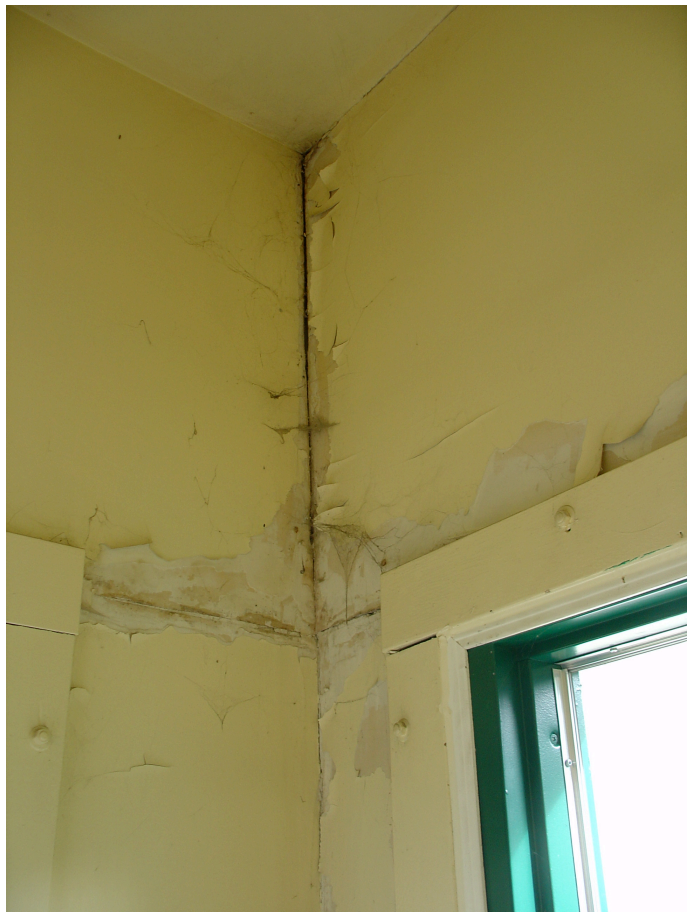
stucco wall interior damage

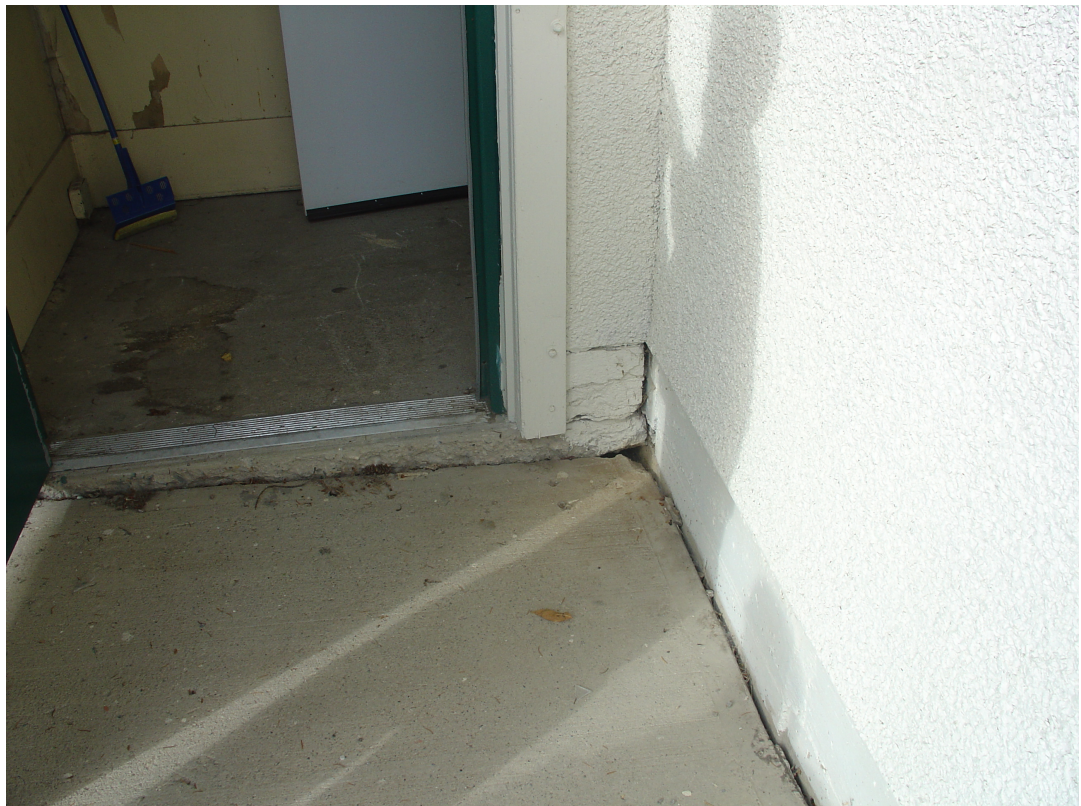
concrete pad settlement

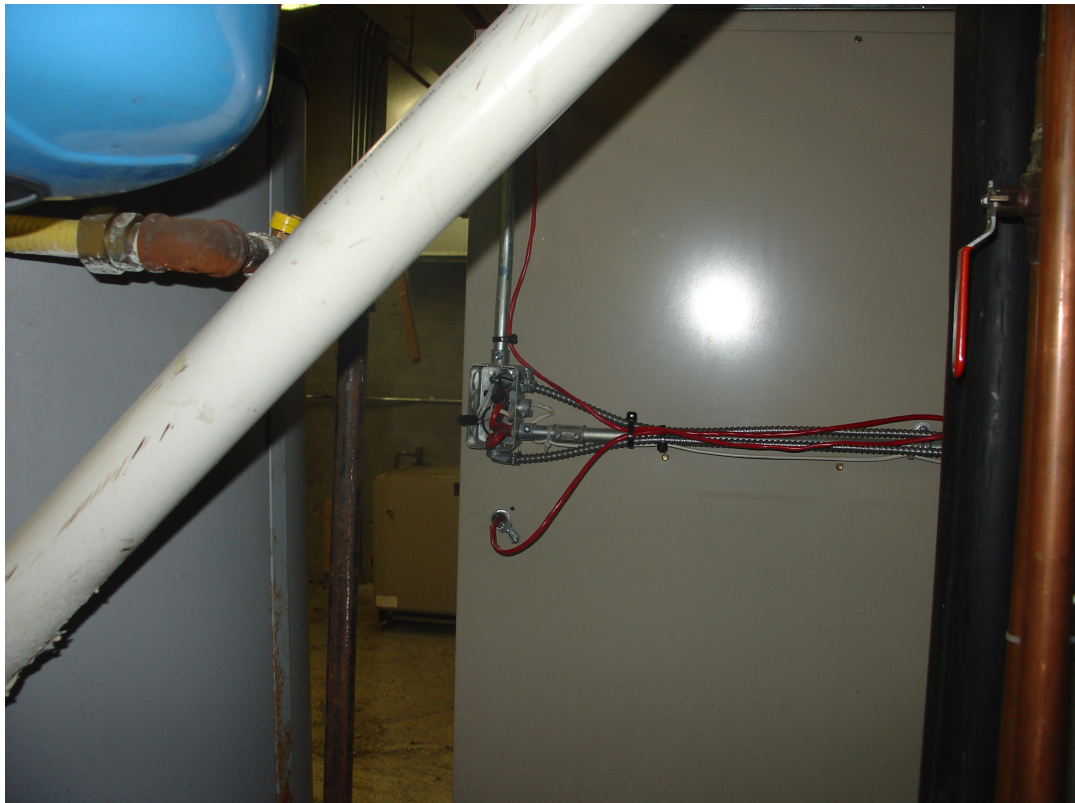
non-compliant boiler wiring

It is beyond the scope of this Report to provide an in-depth analysis of the installed systems, their installed efficiency and the status of the remaining warranty. Based upon the visual review of installations however, it is recommended that in addition to the heating plant wiring terminations noted in the previous section, an Engineer or a qualified Lennox Contractor be engaged to determine if the system as installed, is operating at its optimal efficiency.
